Barataria Bay Waterway West Side Shoreline Protection Summary Data and Graphics

Barmore, J. 2003. *BA-23 Barataria Bay Waterway West Side Shoreline Protection Summary Data and Graphics*. Louisiana Department of Natural Resources, Coastal Restoration Division, Baton Rouge, Louisiana 32pp.

BA-23 Barataria Bay Waterway West Side Shoreline Protection

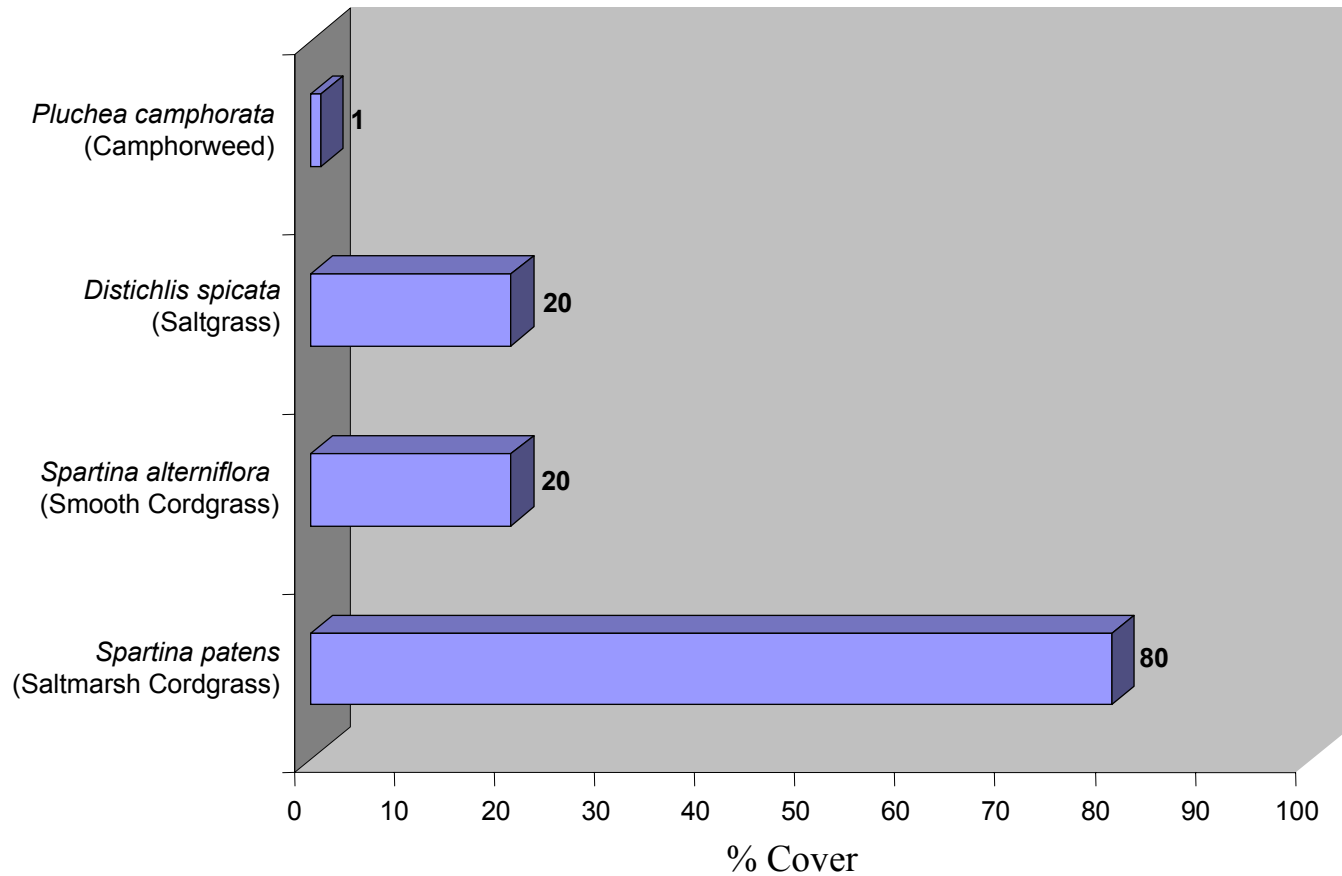
**Vegetation Data (Percent Cover) for the Barataria Bay Waterway West Side Shoreline Protection Project
Station BA23-105
November 1997**

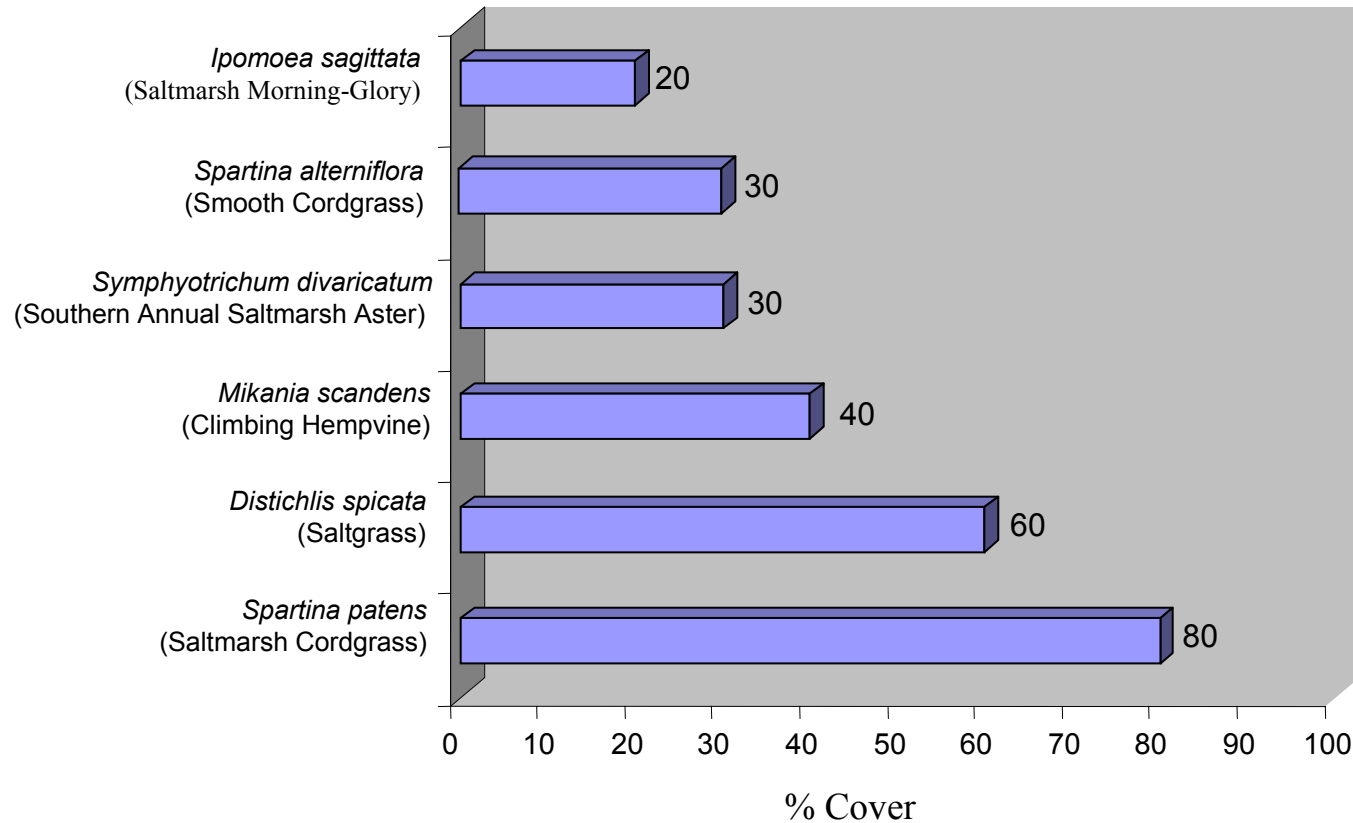
**Vegetation Data (Percent Cover) for the Barataria Bay Waterway West Side Shoreline Protection Project
Station BA23-106
November 1997**

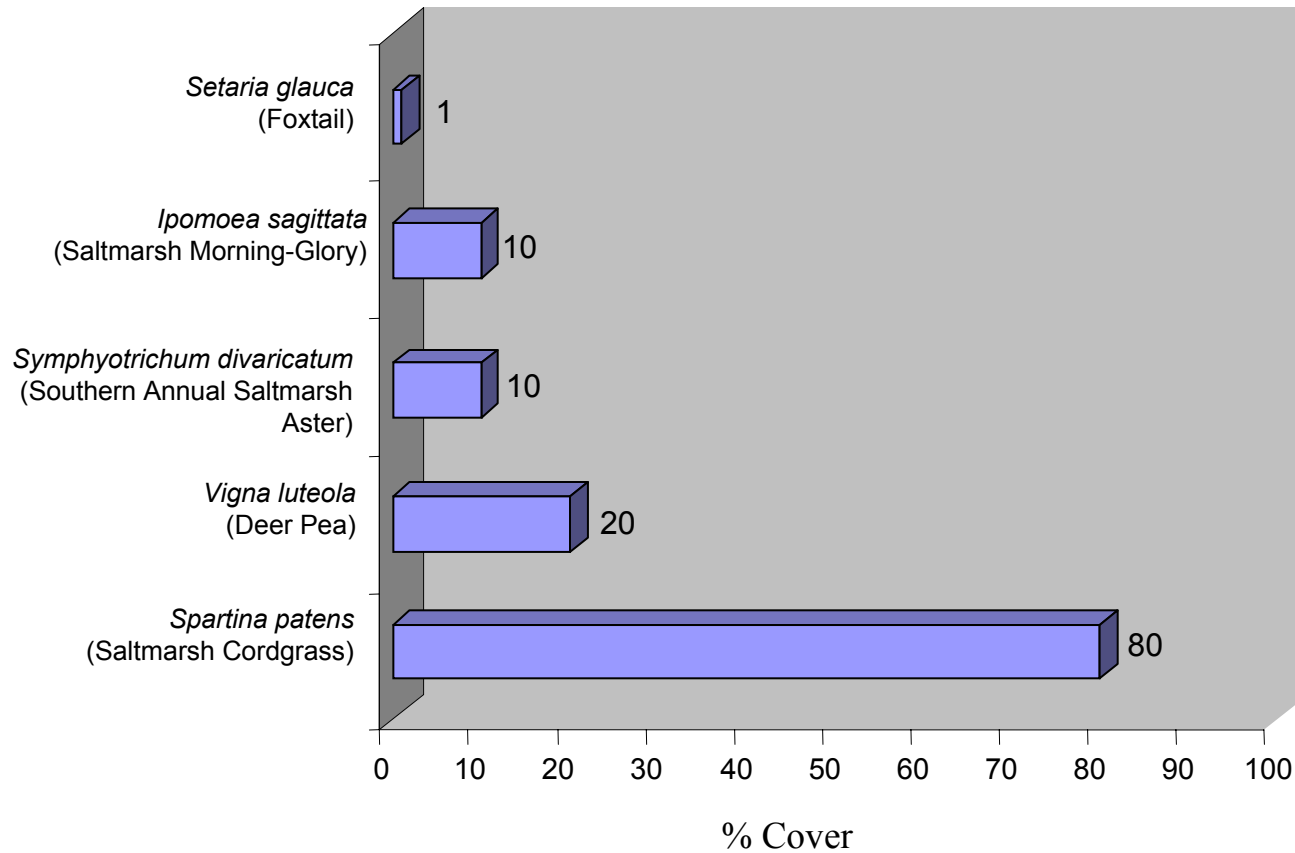
**Vegetation Data (Percent Cover) for the Barataria Bay Waterway West Side Shoreline Protection Project
Station BA23-107
November 1997**

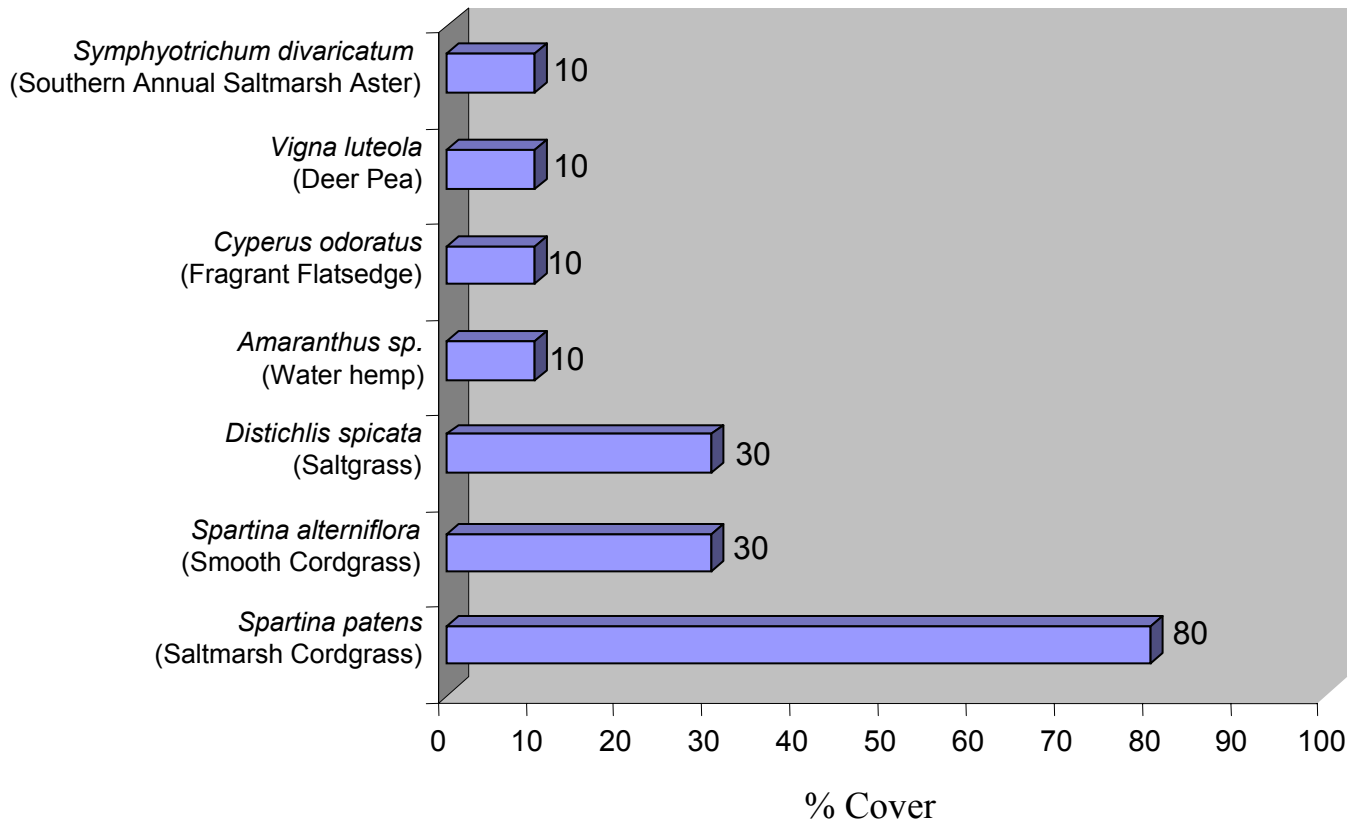
**Vegetation Data (Percent Cover) for the Barataria Bay Waterway West Side Shoreline Protection Project
Station BA23-108
November 1997**

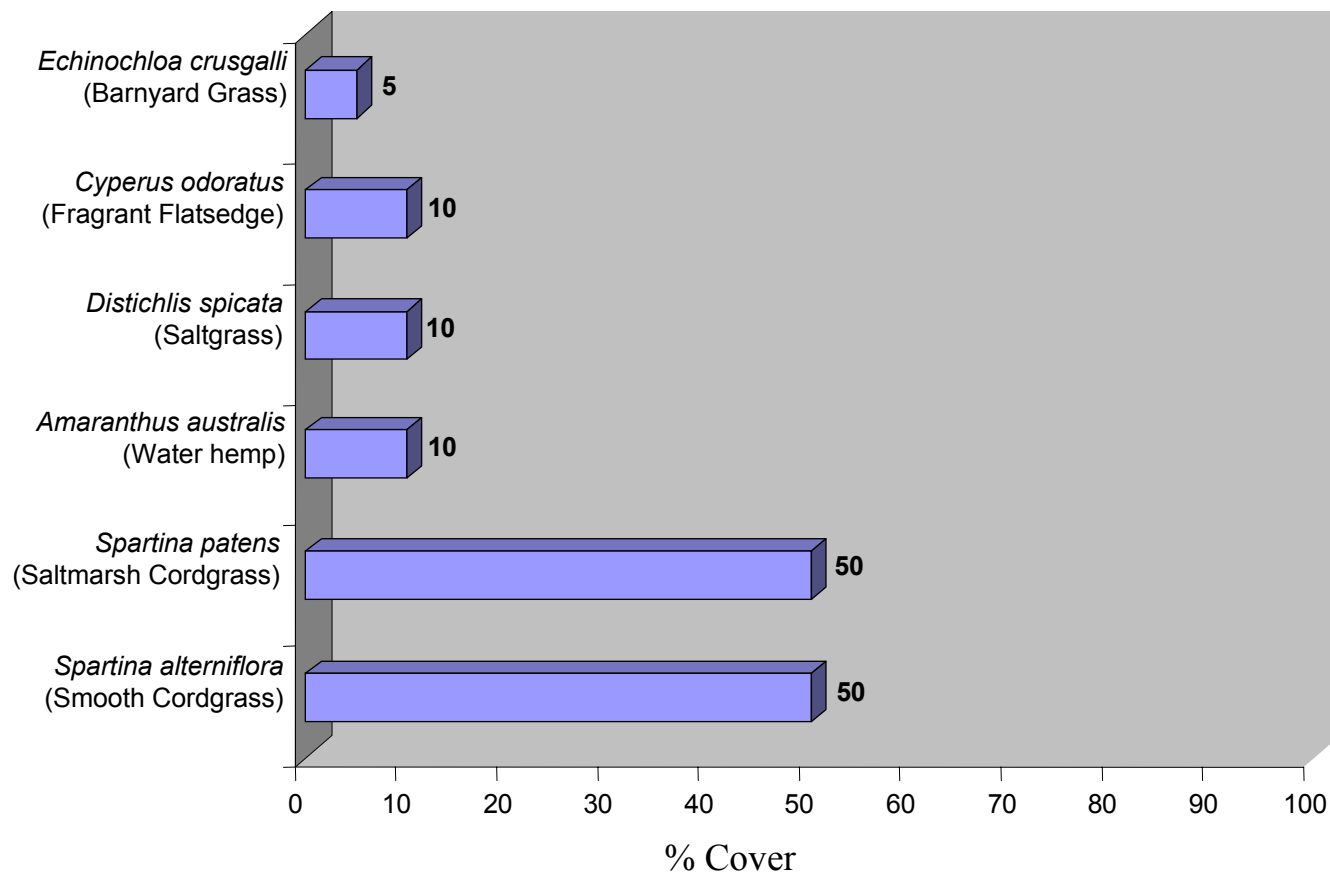
**Vegetation Data (Percent Cover) for the Barataria Bay Waterway West Side Shoreline Protection Project
Station BA23-115
November 1997**

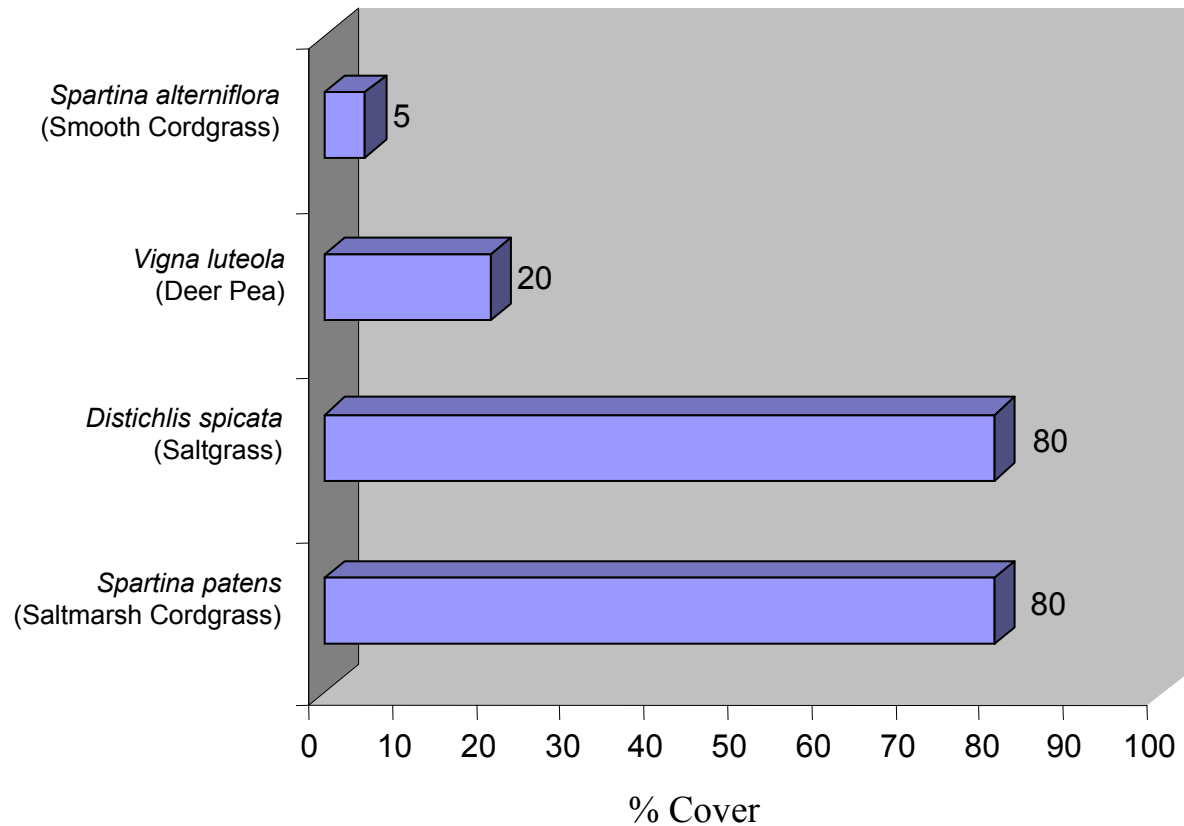
**Vegetation Data (Percent Cover) for the Barataria Bay Waterway West Side Shoreline Protection Project
Station BA23-117
November 1997**

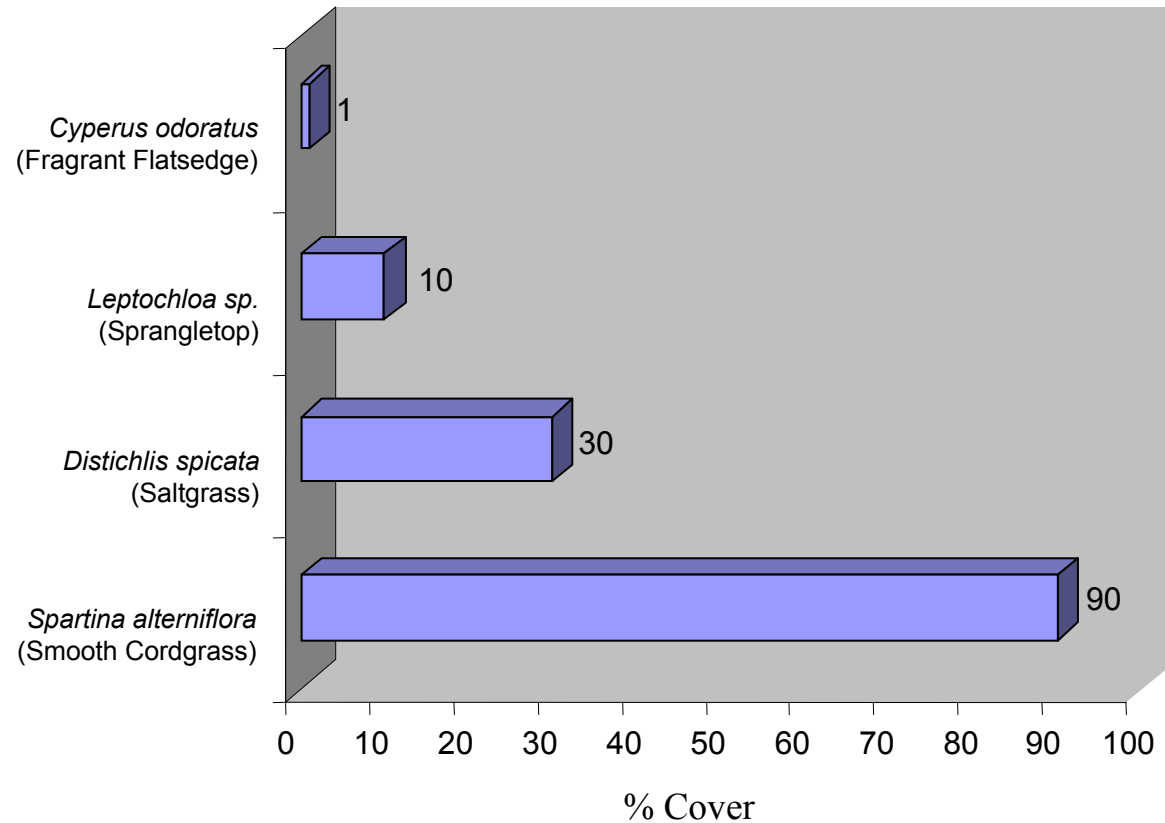
**Vegetation Data (Percent Cover) for the Barataria Bay Waterway West Side Shoreline Protection Project
Station BA23-118
November 1997**

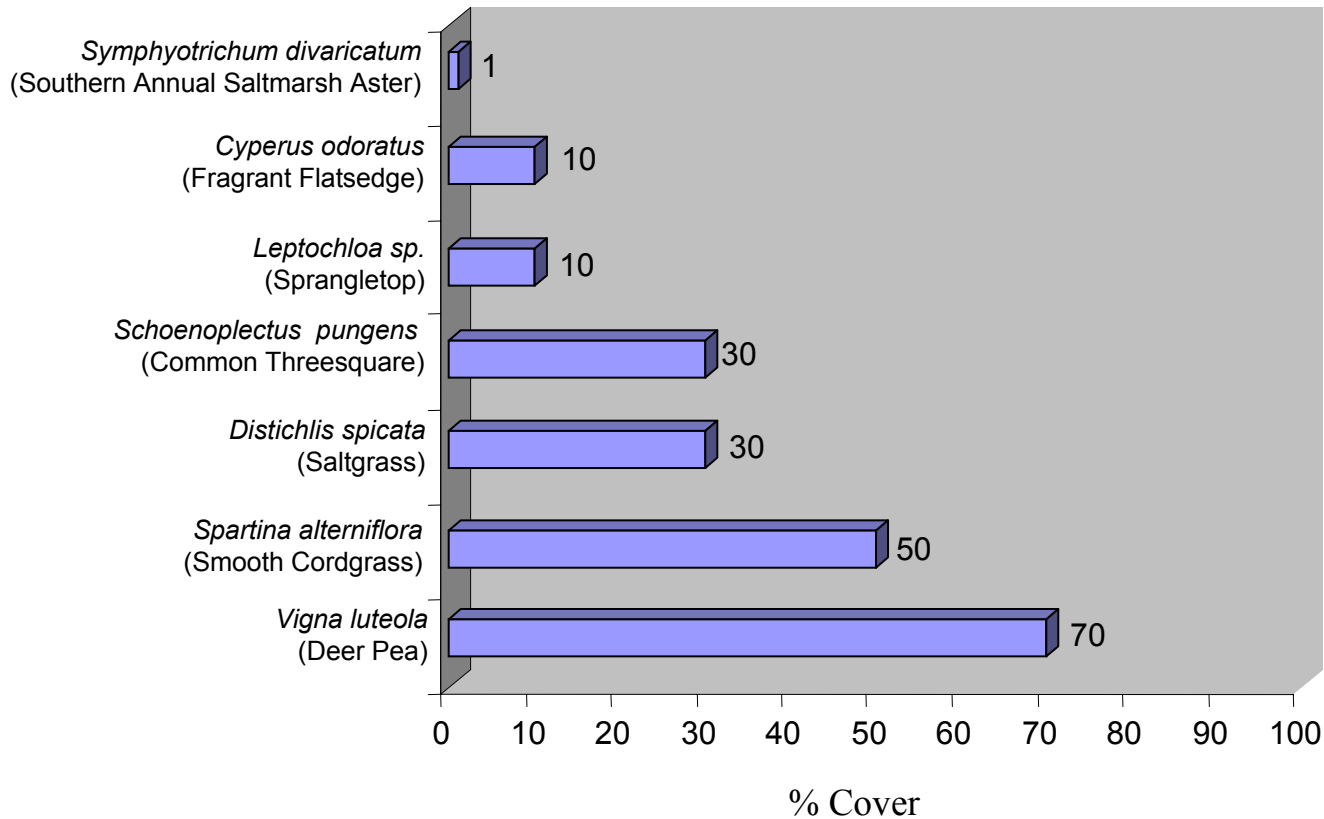
**Vegetation Data (Percent Cover) for the Barataria Bay Waterway West Side Shoreline Protection Project
Station BA23-119
November 1997**

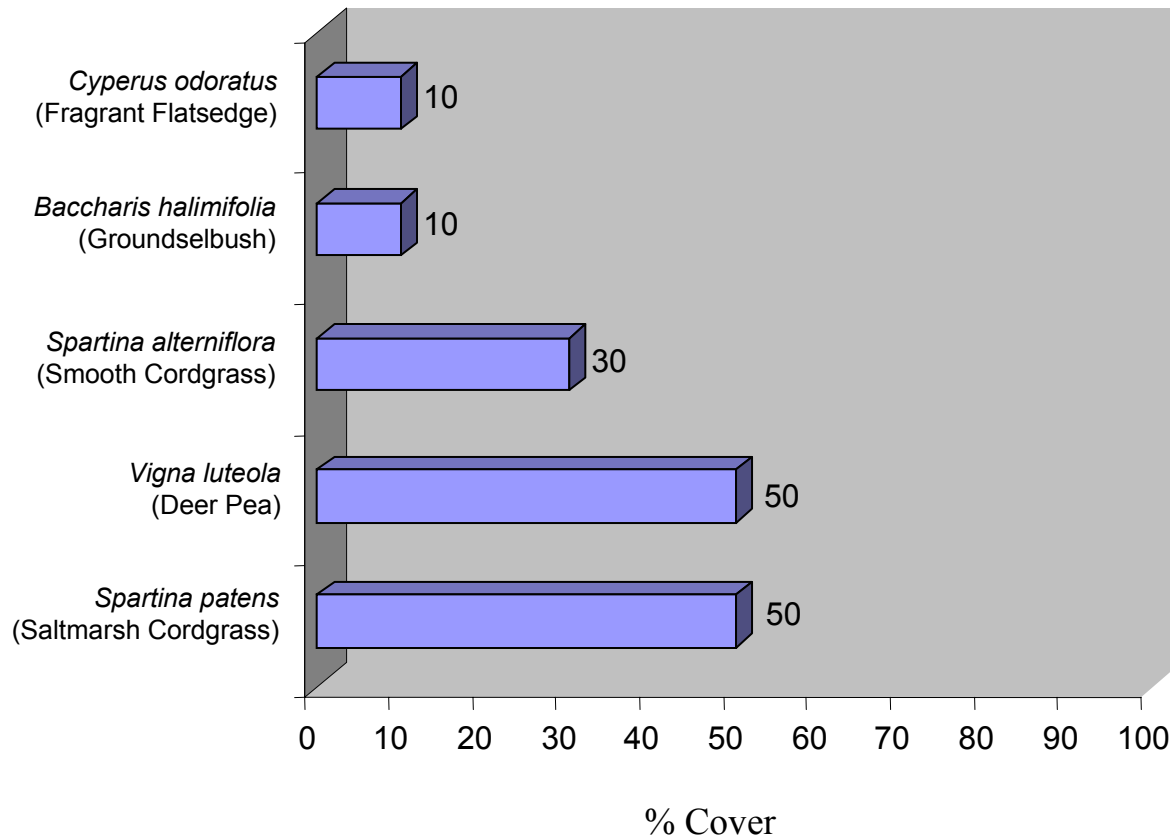
**Vegetation Data (Percent Cover) for the Barataria Bay Waterway West Side Shoreline Protection Project
Station BA23-120
November 1997**
